Forest Cover Loss Mapping

Name of Project: 118 MW Nikachhu Hydropower Project

Location: Tangsibji Gewog

Environment Unit, Tangsibji Hydro Energy Limited
for
118 MW Nikachhu Hydropower Project.

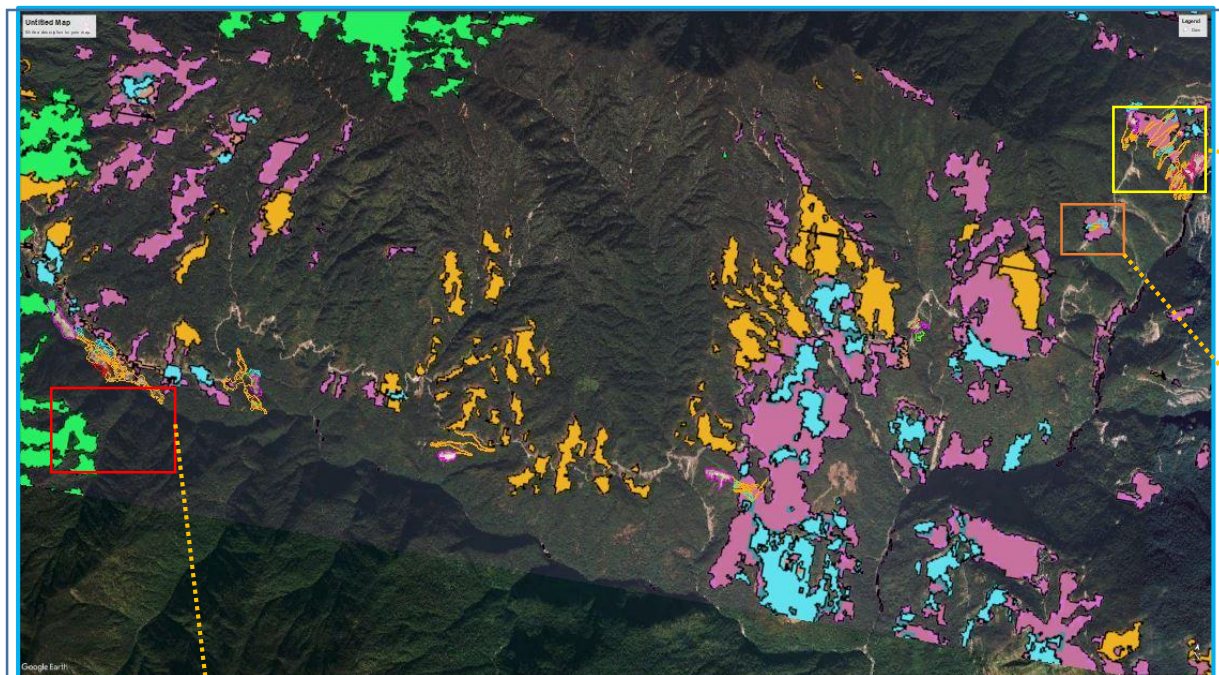
Figure 3: LCMP 2010 overlaid over project cadastral map

Initial coordinates of the project components such as access roads, muck yards, workshops, colony, stock & store yards, 33 kV TL picked by total station and Differential Global Positioning System were imported in Google earth and then Bhutan LCMP (2010) prepared by the MoAF with resolution of 10 m was overlaid to visualize the Google Earth Imagery and classification of the land use. Accordingly, the disturbed areas are manually delineated and classified as muck yards, access roads, contractor construction facilities such as colony's, Dam axis, stockyards, Batching Plants. The coordinates of the 33 kV TL poles was also imported to Google Earth to simulate disturbed area along the 12 meter right of ways from Dam to View point. Refer figure 2, 3, 4, 5 & 6.

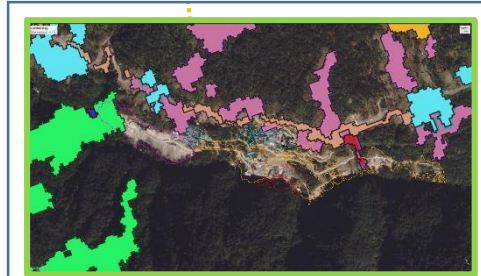
Figure 6: Dam component such as muck yard, access roads, dam axis and colony's developed on mix conifer forest, broadleaved forest, shrub land, agricultural & landslide area

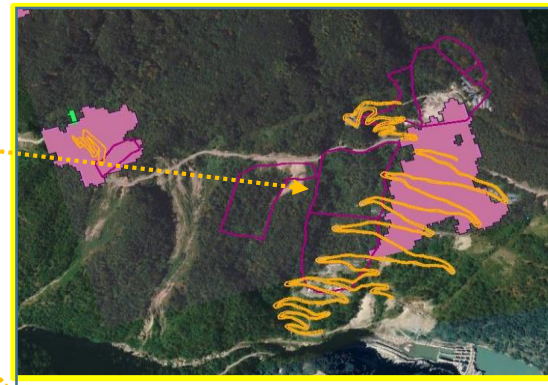
Figure 4: Muck yard of SS, access road, colony developed in shrub land

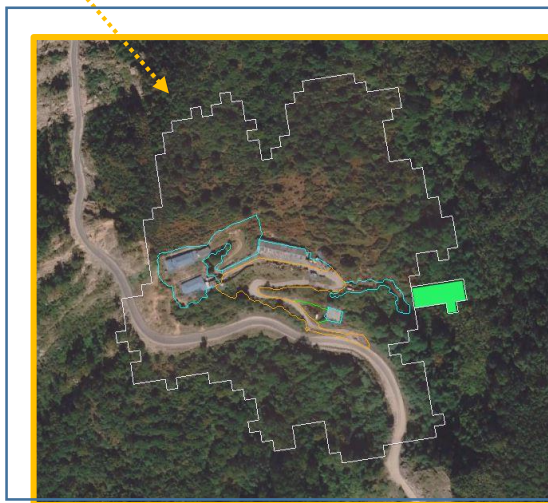
Figure 5: Workshop developed in shrub land as per LCMP 2010

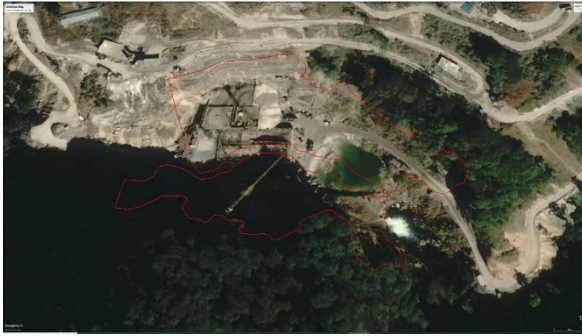
Figure 7: Left bank of Dam not visible in the Google Earth image

During the initial desk assessment, it was observed that some of the classified project components falls in hill side or shade area where manual delineation was not possible. For this, drone images was used wherein slide caused by the construction of the access roads was also delineated. Refer figure 7, 8, 9,10,11,12. Followed by this, the initial field verification

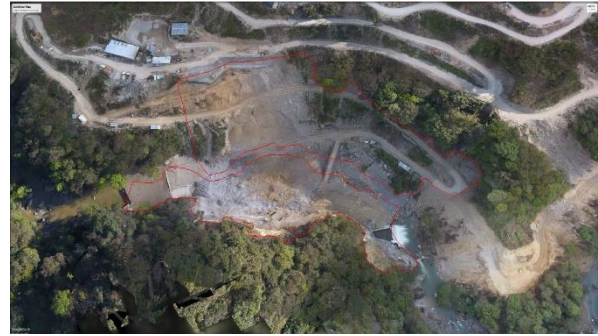
Figure 8: Left bank of Dam visible using drone image & delineated for land use classification

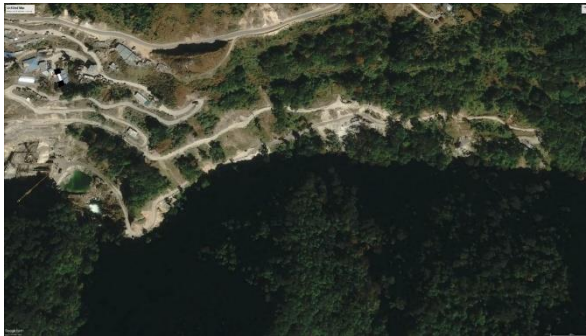
Figure 9: Left bank of access road to Dam no visible in Google Earth image

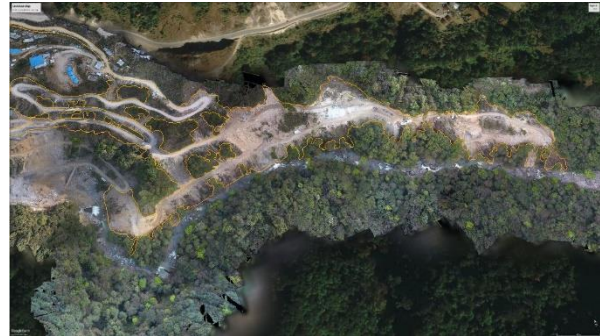
Figure 10: Left bank of the access road to dam visible & delineated for classification of land use using drone image

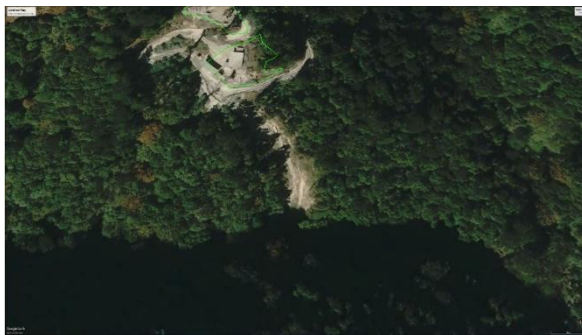
Figure 11: Landslide area along access road of Adit-I in Google Earth image

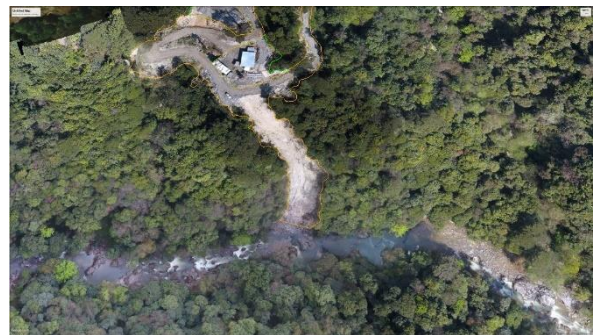
Figure 12: Landslide area delineated using drone image

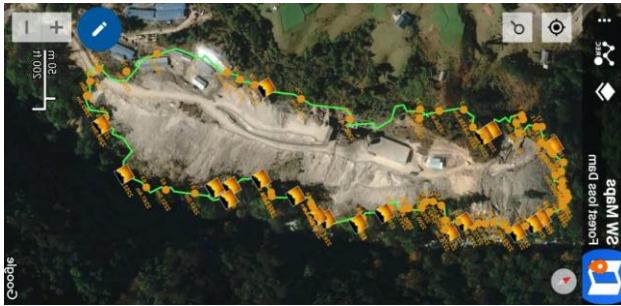
Figure 13: Delineated polygon at site by plotting points in SW Maps

was carried out using numbers of plotted coordinates in SW Maps and also in hard copy. This was also done to manually validate the accuracy achieved by SW Maps and Google Earth image. Refer figure 13 & 14.

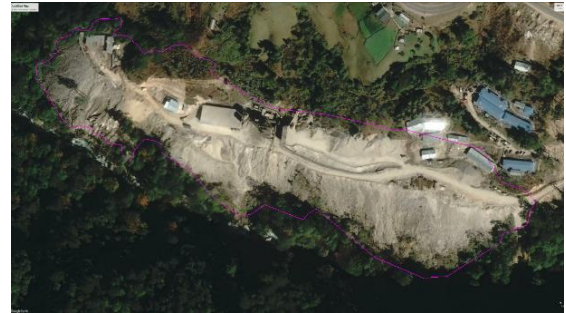
Figure 14: Coordinates from SW Maps are imported in Google Earth

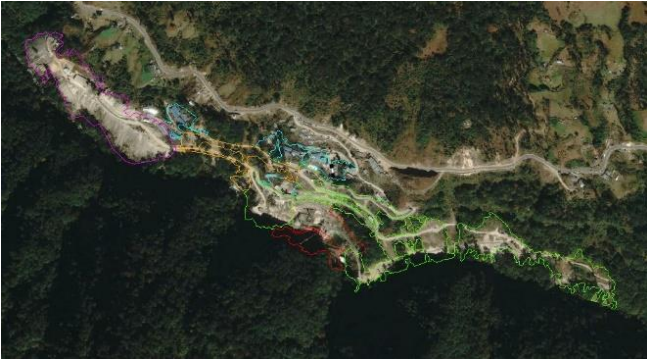
Figure 16.1: Forest area cleared by Dam component as of 2022

With help of the LCMP 2010, comparative Google Earth imagery of 2003, 2006, 2010, 2014, 2017, 2021 and 2022, determining the forest area was convenient for delineation. Refer figure 16.1 to 22.2. The delineated forest area was imported in Qgis to calculate the forest cover loss.

It was also observed that the right bank of the submergence area falls in shade area and not accessible considering its steep gradient and out crop cliff. Refer figure 16.1, picture 1.5 & 1.6. Based on these findings, it is being recommend to carry out a drone survey once before and after removal of the trees in submergence area. .

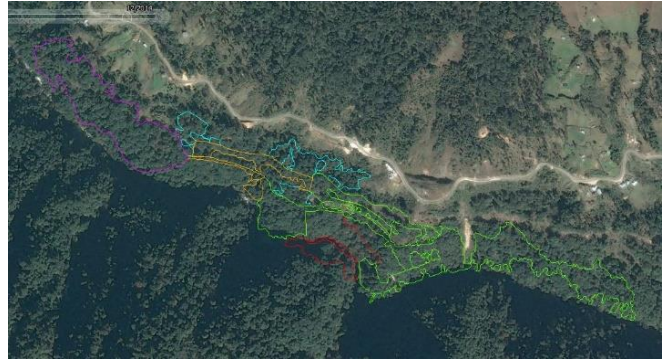
Figure 16.2: Forest cover at the dam site in 2014

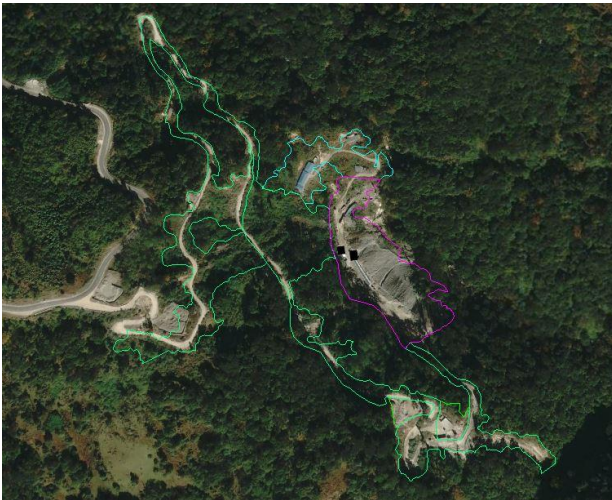
Figure 17.1: Forest area cleared by Adit-I component as of 2022

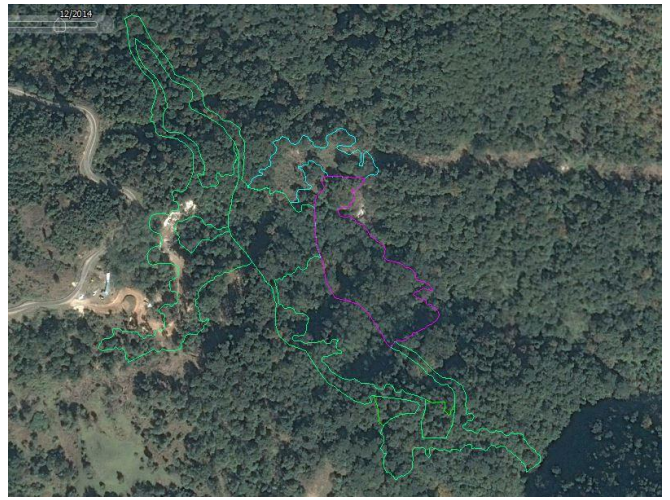
Figure 17.2: Forest cover at Adit-I in 2014

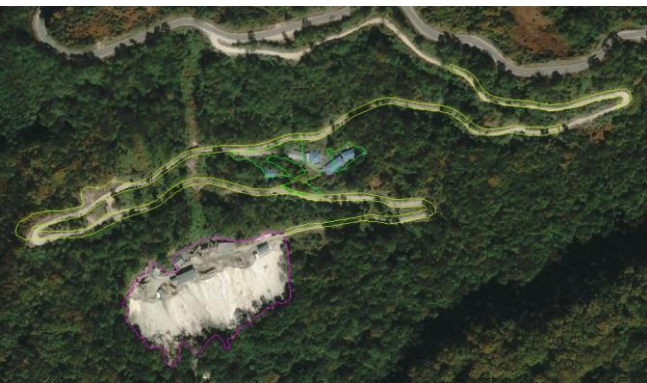
Figure 18.1: Forest area cleared by Adit-II component as of 2022

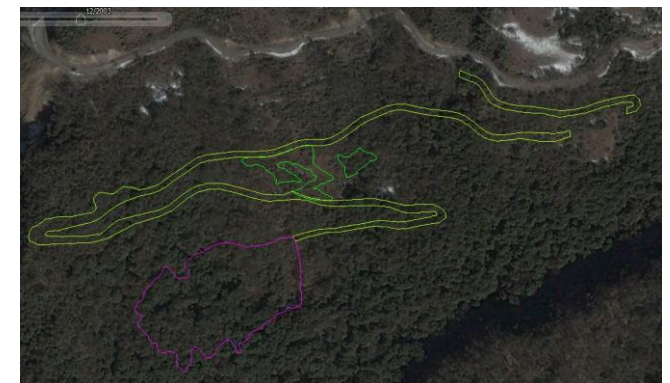
Figure 18.2: Forest cover at Adit-II in 2014

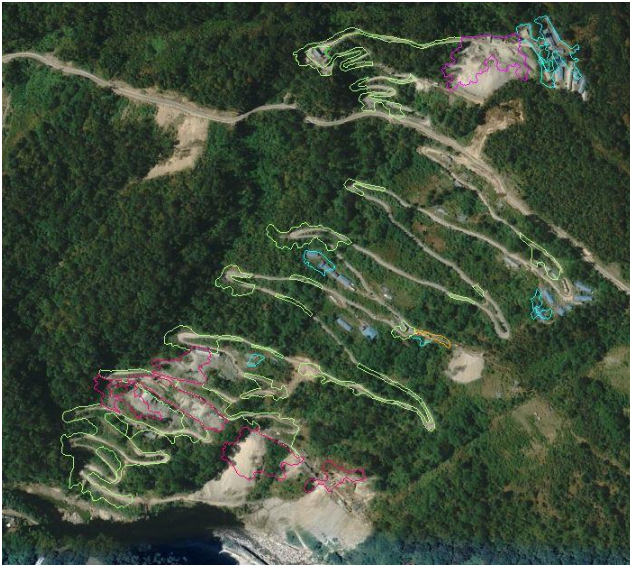
Figure 19.1: Forest area cleared by SS, IPS & PH component as of 2022

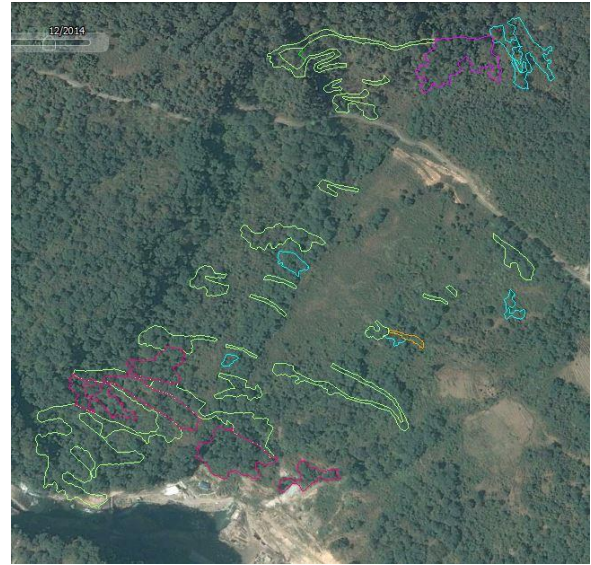
Figure 19.2: Forest cover at SS, IPS & PH in 2014

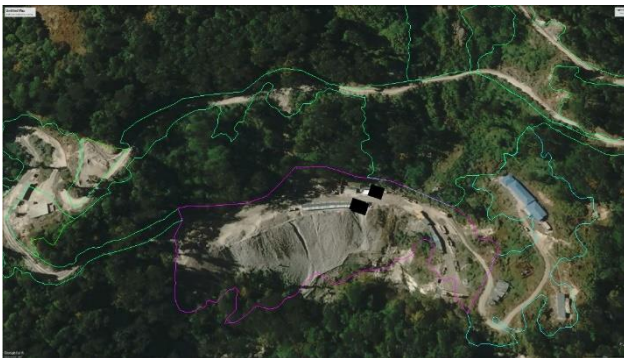
Figure 20.1: Forest area cleared by muckyard at Adit-II as of 2022

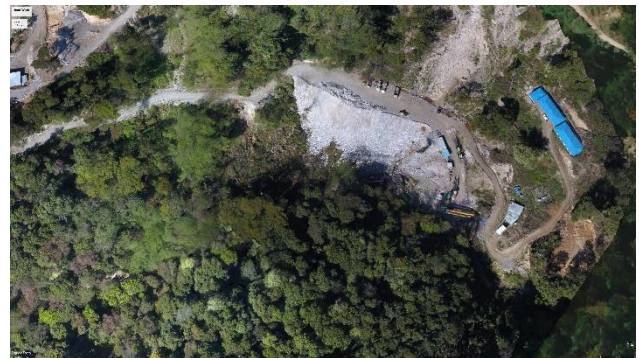
Figure 20.2: Forest area cleared in patches during development of muckyard at Adit-II

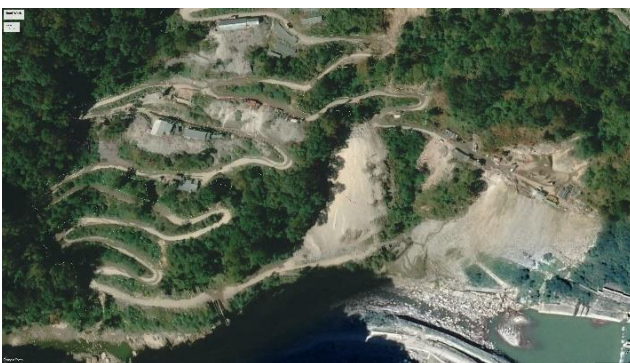
Figure 21.1: Forest are cleared by access road & Muck yard at Power House as of 2022

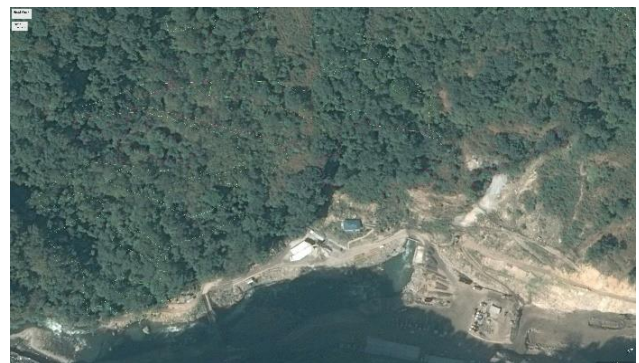
Figure 21.2: Status of the Forest cover at Power House in 2014

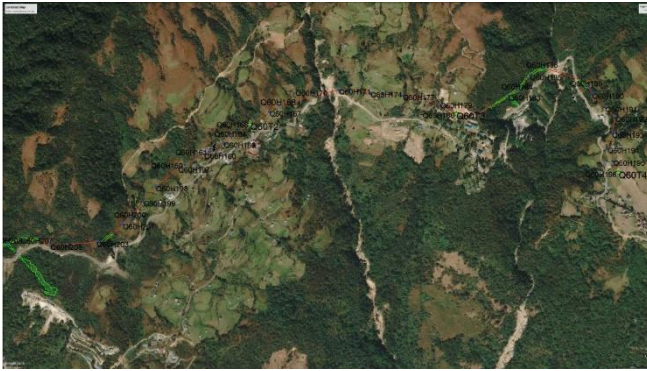
Figure 22.1: Forest area cleared by 33 kV TL as of 2022

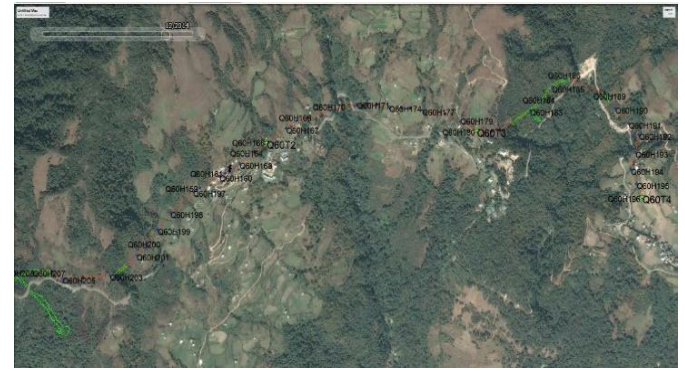
Figure 2.2: Forest cover along the 33 kV TL from Adit-III to Tsangkha in 2014

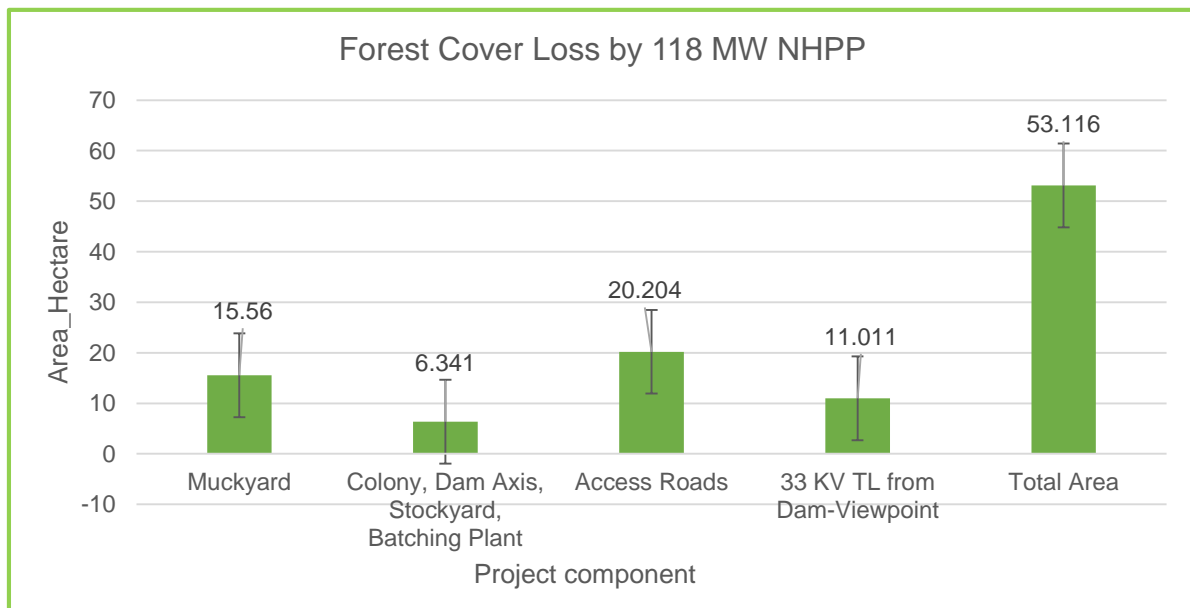
Figure 23: Forest area cleared by project component

With manual digitization of the disturbed area and forest area through use of Google Earth images, SW Maps and with repeated field visit, the delineated forest cover area was converted to shape file and imported in Qgis to calculate the area. The forest cover loss measured 53.116 hectares.

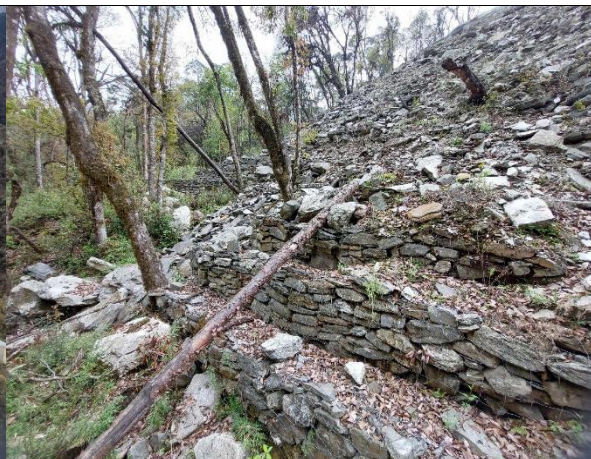
Picture 1.2: Gabion wall constructed at the base of the upstream muck yard of Dam

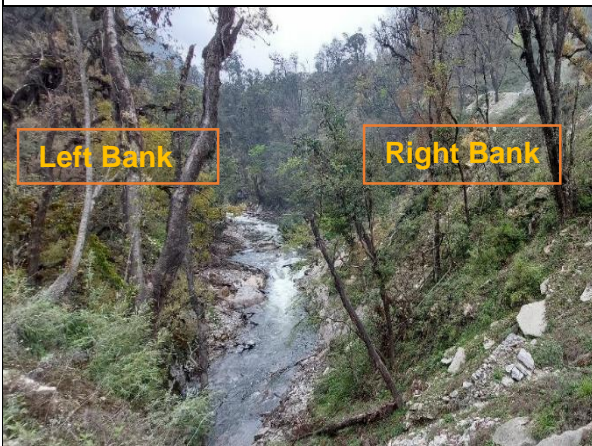
Picture 1.5: Left & right bank slope upstream view from Dam

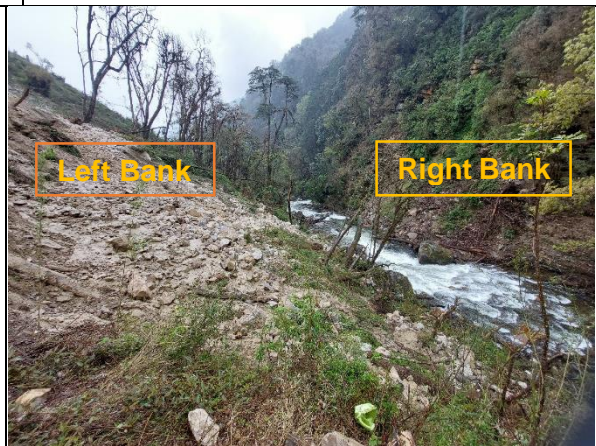
Picture 1.6: Right bank & left bank slope downstream view from upstream muck yard

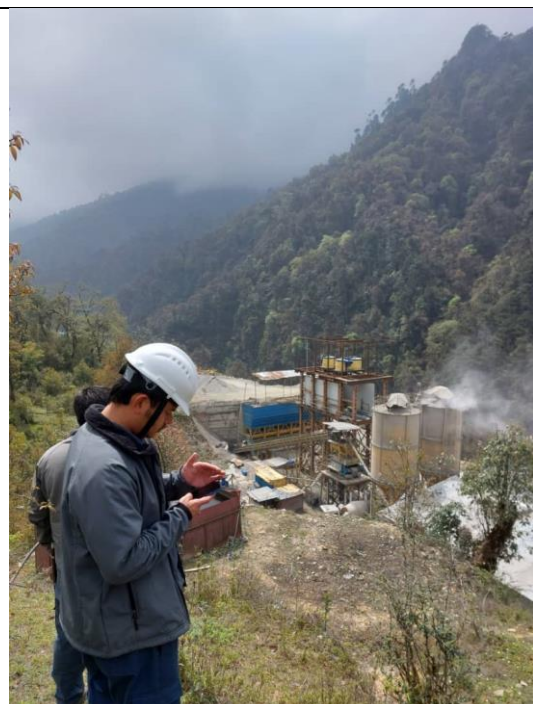
Picture 2.0: Field validation using SW Maps to draw polygon using plotted points

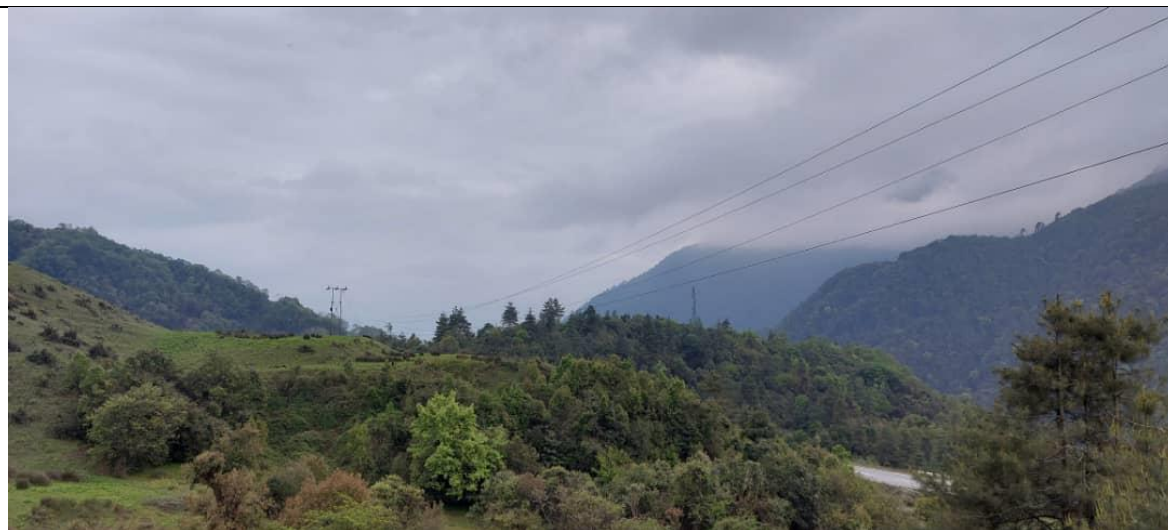
Picture 3.0:Vegetation not cleared for line stringing of 33 kV TL at Banglapokto subject to meeting the clearance height

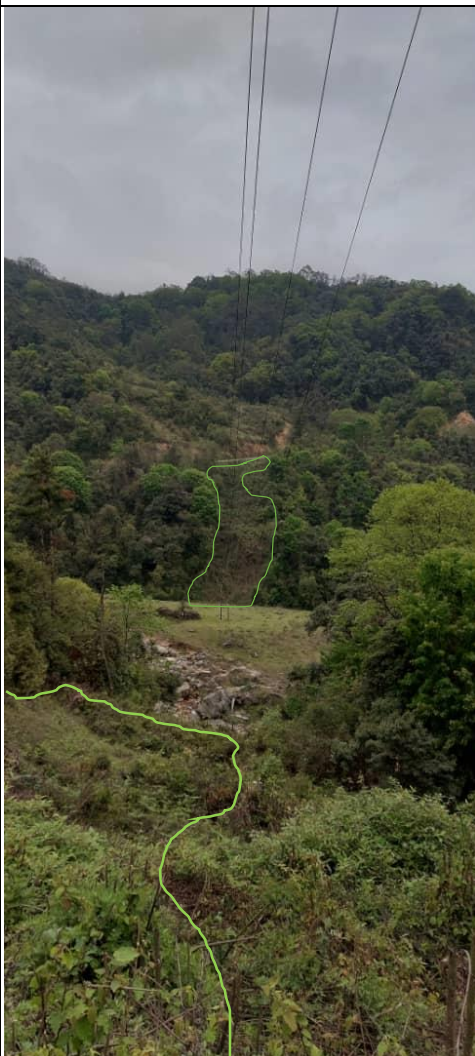
Picture 3.1: Vegetation cleared along 33 kV TL row at Nyelamchhu area
